# Your Home Inspection Report

123 somewhere  
Shoreline, WA 98155

11:48 May 20, 2015

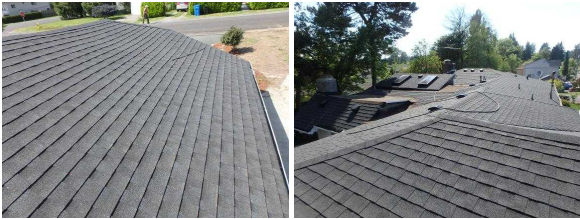
Material: Asphalt shingle **Roof needs to be blown clean of tree debris on a regular basis. Inspector suggests using an air blower over other methods.**

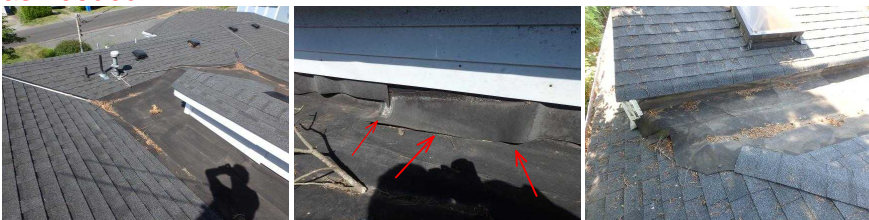
Material: Rolled roof material Torch down **A qualified roofing contractor is recommended to evaluate and estimate repairs.**

**A portion of the roofing material appears to be coming loose from behind the siding... have a roofer repair/replace as needed.**

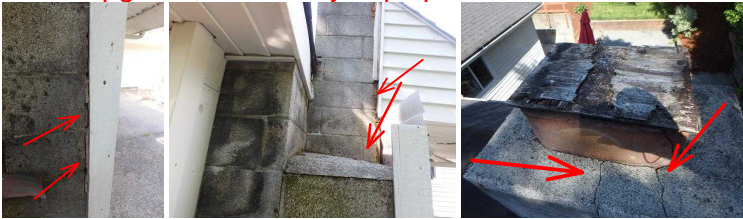
Flue/Flue Cap: Terracotta tile flue / Mortar cap **Keeping Mortar Chimney Caps Sealed:** Most masonry chimneys are capped with a Portland Cement mortar cap. Stress fractures and shrinkage cracks typically develop in such caps soon after installation. These cracks should be kept sealed with a quality Urethane caulking material so as to prevent water infiltration and subsequent freeze-thaw damage to the chimney cap and masonry work below.

**No spark arrestor or rain cap had been installed above the flue to prevent the escape of hot embers or rain entry. As an upgrade, a chimney cap/spark arrestor could be installed.**

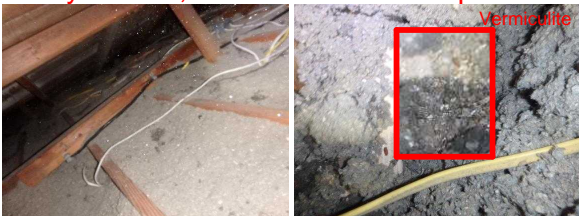
Insulation: Blown in, Cellulose, Rockwool **What appeared to be vermiculite insulation was found in the attic. Vermiculite produced prior to 1991 may contain asbestos, less so if mined after 1991. When vermiculite insulation is present in attics, the EPA recommends that it be left undisturbed and that the attic not be used for storage, and that people (especially children) should not enter the attic. If the client is concerned about this material posing a safety hazard, then consult with a qualified asbestos abatement specialist or industrial hygienist.**

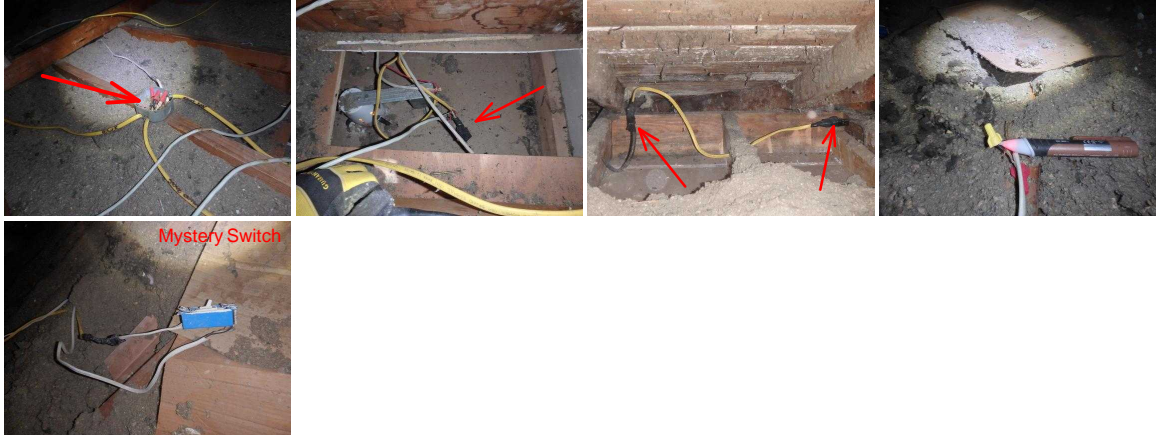
Electrical splices should be contained within an approved junction box with a cover plate installed.

This condition is a shock/electrocution and potential fire hazard and should be corrected by a qualified electrical contractor.

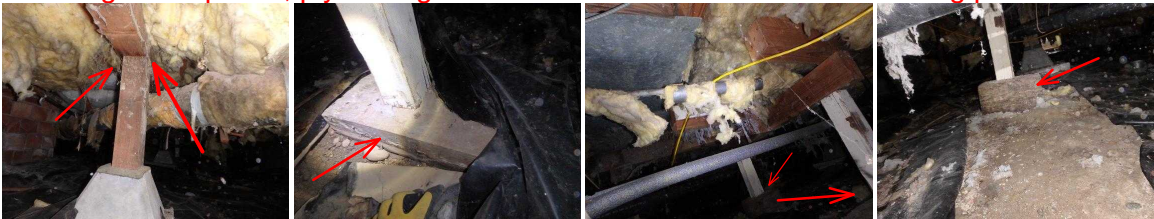
Piers/Posts: Poured piers and wood posts; WOODEN PIERS AND POSTS Improper construction technique to have wooden posts sitting on wooden blocks.. replace wooden blocks with concrete piers.

One or more support posts were not positively secured to the beam above. While this is common in older homes, current standards require positive connections between support posts and beams above for earthquake reinforcement. Recommend that a qualified contractor repair per standard building practices. For example, by installing metal plates, plywood gussets or dimensional lumber connecting posts and beams.

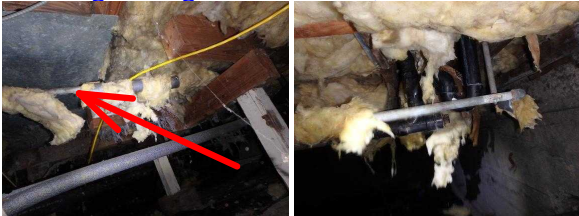
Supply Lines Insulated? **Insulation for one or more water supply pipes in the crawl space was missing.**

**Recommend replacing or installing insulation on pipes per standard building practices to prevent them from freezing during cold weather, and for better energy efficiency with hot water supply pipes.**

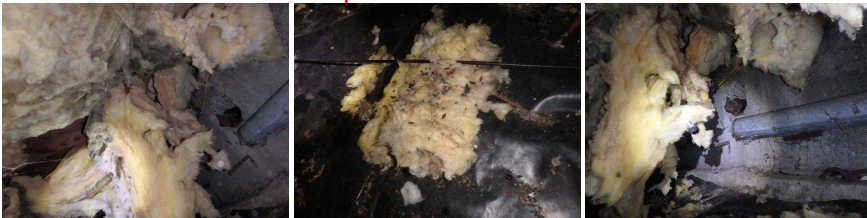
Insulation: Fiberglass **Evidence of rodents tunneling and living in the insulation. All rodent affected insulation should be removed and replaced.**

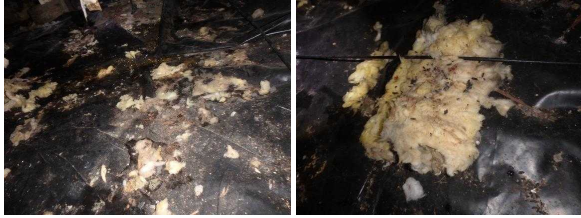
Animal/Rodent Activity: Rodent Conditions were observed in the crawlspace indicating evidence of rodent activity. The first step in eliminating rodents from the house is to seal all possible openings. Careful work sealing cracks, gaps and openings with caulking, wire mesh, wood trim and steel wool will be necessary to prevent future rodent entry. After these corrections are made, monitoring future activity can be made easier by having an insulation contractor replace and level the insulation which was compressed/damaged by rodent activity. If the problem persists, we recommend obtaining the advice and services of a competent, licensed Pest Control Operator.

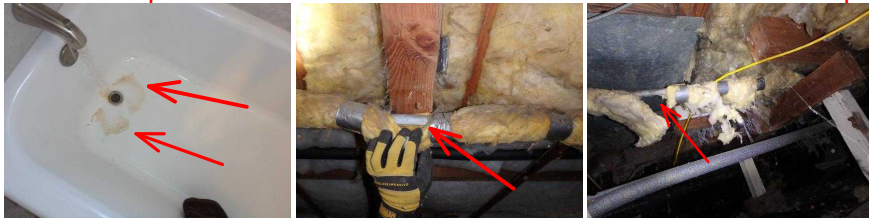
**Water Lines: Galvanized and copper** Galv significant corrosion/rust H2O: Evidence of significant corrosion or deterioration of the galvanized supply piping was observed during this inspection, and rust was observed in the water when the faucets were operated.

A licensed plumber is recommended to evaluate and estimate repairs

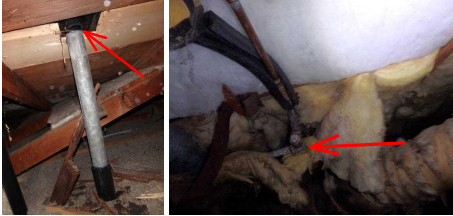
Vent Pipes: ABS, Galvanized vent pipe is disconnected in the attic... making an entry point for rainwater... the vent pipes should be solid all the way to the roof, so that any rain water that falls in the pipe will be contained in the pipe.

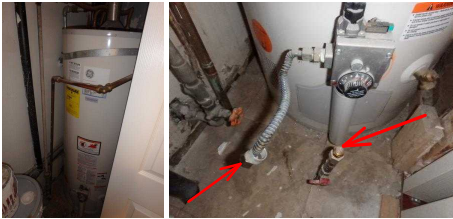
Water Heater Operation: NOT Functional at time of inspection The water was turned off and disconnected from the gas supply, so this fixture could not be tested.

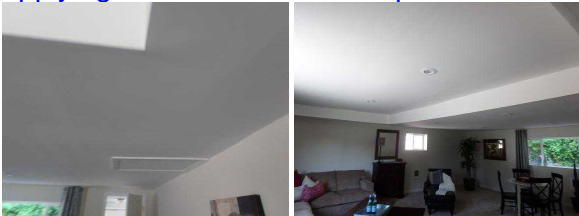
Ceiling: Drywall **Extremely shoddy workmanship on ceiling in rec room... For a better visual impact I'd suggest applying texture to hide the imperfections.**

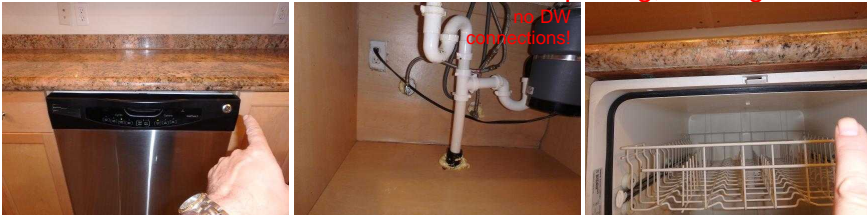
Current dishwasher is not centered in the opening, making the door hit on the right cabinet...

Suggest having a licensed and bonded contractor replace the dishwasher with a functioning one and verify all connections are appropriately made.

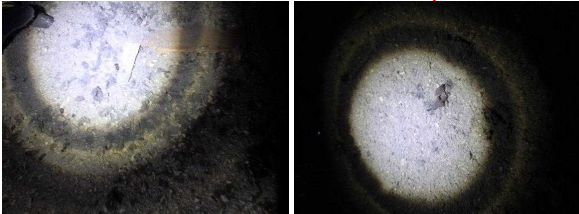
Animal/Rodent: Active Conditions were observed in the crawlspace and the attic indicating evidence of rodent activity. The first step in eliminating rodents from the house is to seal all possible openings. Careful work sealing cracks, gaps and openings with caulking, wire mesh, wood trim and steel wool will be necessary to prevent future rodent entry. After these corrections are made, monitoring future activity can be made easier by having an insulation contractor replace and level the insulation which was compressed/damaged by rodent activity. Obtain the advice and services of a competent, licensed Pest Control Operator.

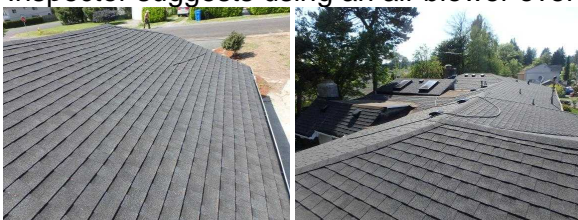
8. Main Roof Surface Material: Asphalt shingle Roof needs to be blown clean of tree debris on a regular basis. Inspector suggests using an air blower over other methods.

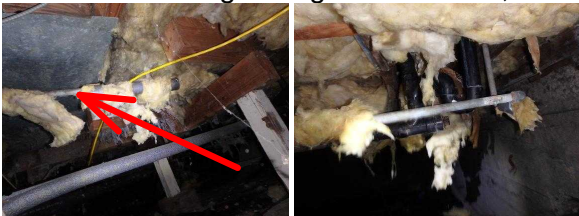
13. Main Crawl Space Supply Lines Insulated? Insulation for one or more water supply pipes in the crawl space was missing. Recommend replacing or installing insulation on pipes per standard building practices to prevent them from freezing during cold weather, and for better energy efficiency with hot water supply pipes.

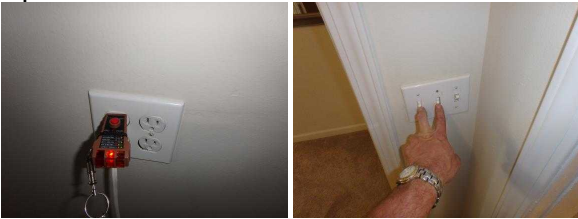
Mystery switch at the (hall wall immediately in front of master door ), we could not determine it's purpose, inquire with current owner to determine it's function.

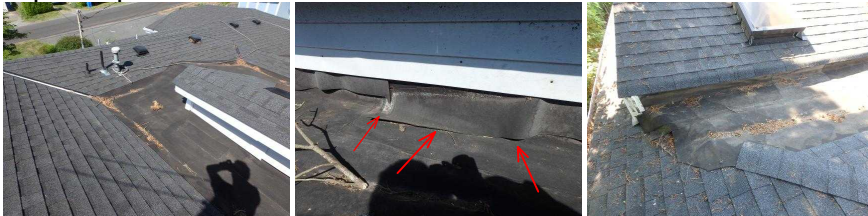
4. Family room conversion areas Roof Surface Material: Rolled roof material Torch down A qualified roofing contractor is recommended to evaluate and estimate repairs.

A portion of the roofing material appears to be coming loose from behind the siding... have a roofer repair/replace as needed.

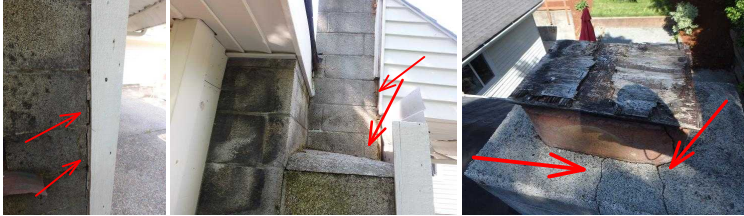
5. Back Chimney Flue/Flue Cap: Terracotta tile flue / Mortar cap Keeping Mortar Chimney Caps Sealed: Most masonry chimneys are capped with a Portland Cement mortar cap. Stress fractures and shrinkage cracks typically develop in such caps soon after installation. These cracks should be kept sealed with a quality Urethane caulking material so as to prevent water infiltration and subsequent freeze-thaw damage to the chimney cap and masonry work below.

No spark arrestor or rain cap had been installed above the flue to prevent the escape of hot embers or rain entry. As an upgrade, a chimney cap/spark arrestor could be installed.

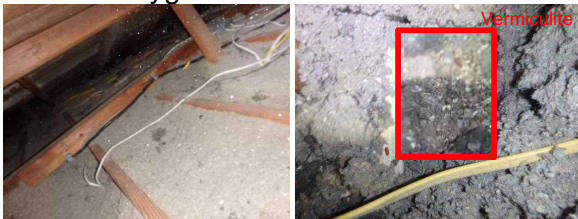
7. Main Attic Insulation: Blown in, Cellulose, Rockwool What appeared to be vermiculite insulation was found in the attic. Vermiculite produced prior to 1991 may contain asbestos, less so if mined after 1991. When vermiculite insulation is present in attics, the EPA recommends that it be left undisturbed and that the attic not be used for storage, and that people (especially children) should not enter the attic. If the client is concerned about this material posing a safety hazard, then consult with a qualified asbestos abatement specialist or industrial hygienist.

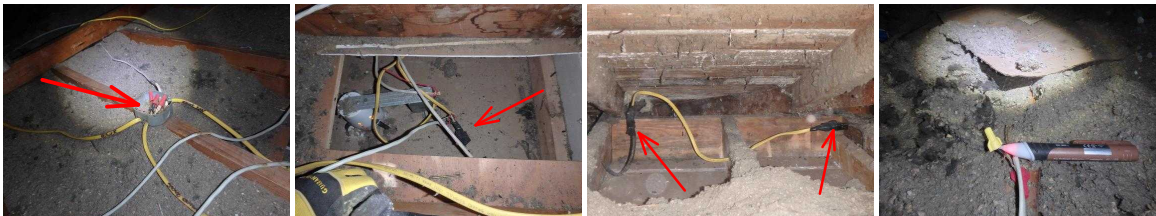
8. Main Attic Wiring/Lighting: 120 VAC Energized electrical splices not contained within a junction box and exposed to touch were visible in the attic at the time of the inspection. Electrical splices should be contained within an approved junction box with a cover plate installed. This condition is a shock/electrocution and potential fire hazard and should be corrected by a qualified electrical contractor.

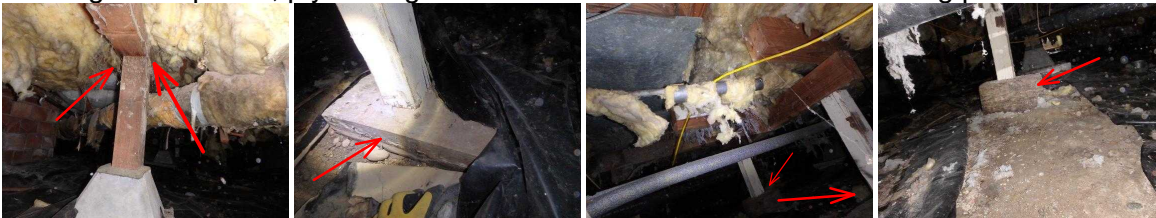
10. Piers/Posts: Poured piers and wood posts; WOODEN PIERS AND POSTS Improper construction technique to have wooden posts sitting on wooden blocks.. replace wooden blocks with concrete piers.

One or more support posts were not positively secured to the beam above. While this is common in older homes, current standards require positive connections between support posts and beams above for earthquake reinforcement. Recommend that a qualified contractor repair per standard building practices. For example, by installing metal plates, plywood gussets or dimensional lumber connecting posts and beams.

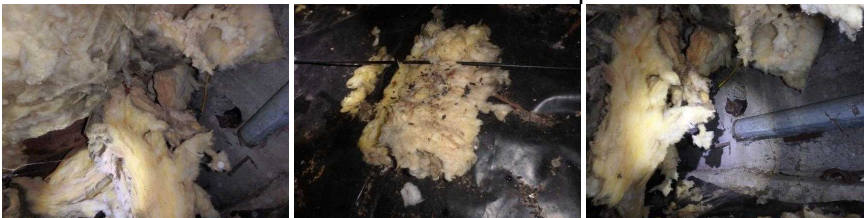
11. Main Crawl Space Insulation: Fiberglass Evidence of rodents tunneling and living in the insulation. All rodent affected insulation should be removed and replaced.

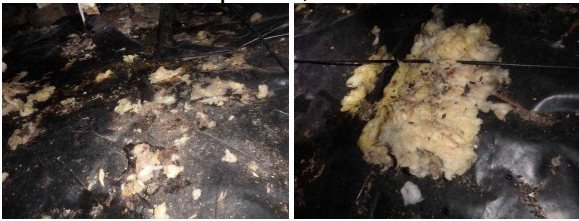
13. Main Crawl Space Animal/Rodent Activity: Rodent Conditions were observed in the crawlspace indicating evidence of rodent activity. The first step in eliminating rodents from the house is to seal all possible openings. Careful work sealing cracks, gaps and openings with caulking, wire mesh, wood trim and steel wool will be necessary to prevent future rodent entry. After these corrections are made, monitoring future activity can be made easier by having an insulation contractor replace and level the insulation which was compressed/damaged by rodent activity. If the problem persists, we recommend obtaining the advice and services of a competent, licensed Pest Control Operator.

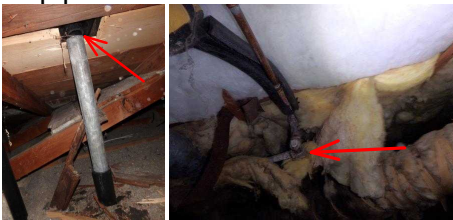
20. Vent Pipes: ABS, Galvanized vent pipe is disconnected in the attic... making an entry point for rainwater... the vent pipes should be solid all the way to the roof, so that any rain water that falls in the pipe will be contained in the pipe.

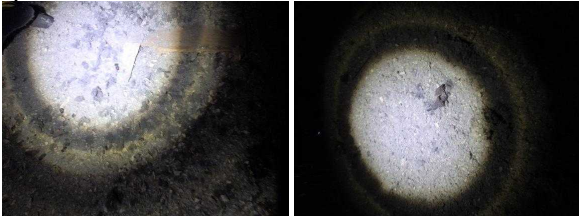
31. Crawl Space, Attic Pest Activity Animal/Rodent: Active Conditions were observed in the crawlspace and the attic indicating evidence of rodent activity. The first step in eliminating rodents from the house is to seal all possible openings. Careful work sealing cracks, gaps and openings with caulking, wire mesh, wood trim and steel wool will be necessary to prevent future rodent entry. After these corrections are made, monitoring future activity can be made easier by having an insulation contractor replace and level the insulation which was compressed/damaged by rodent activity. Obtain the advice and services of a competent, licensed Pest Control Operator.
