# Your Home Inspection Report

123 somewhere  
Shoreline, WA 98155

11:48 May 20, 2015

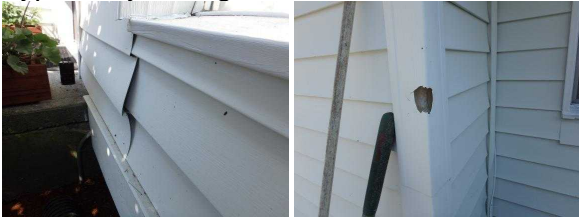
### Primary Siding Exterior Surface

Type: Vinyl siding

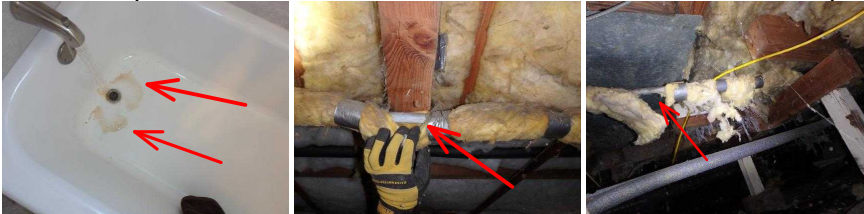
19. Water Lines: Galvanized and copper Galv significant corrosion/rust H2O: Evidence of significant corrosion or deterioration of the galvanized supply piping was observed during this inspection, and rust was observed in the water when the faucets were operated.

A licensed plumber is recommended to evaluate and estimate repairs
